DELET-TR-80-1

FAILURE STUDIES OF Au-Sn AND Au-Au INNER LEAD BONDS

Stanley Firestone
ELECTRONICS TECHNOLOGY & DEVICES LABORATORY

January 1980

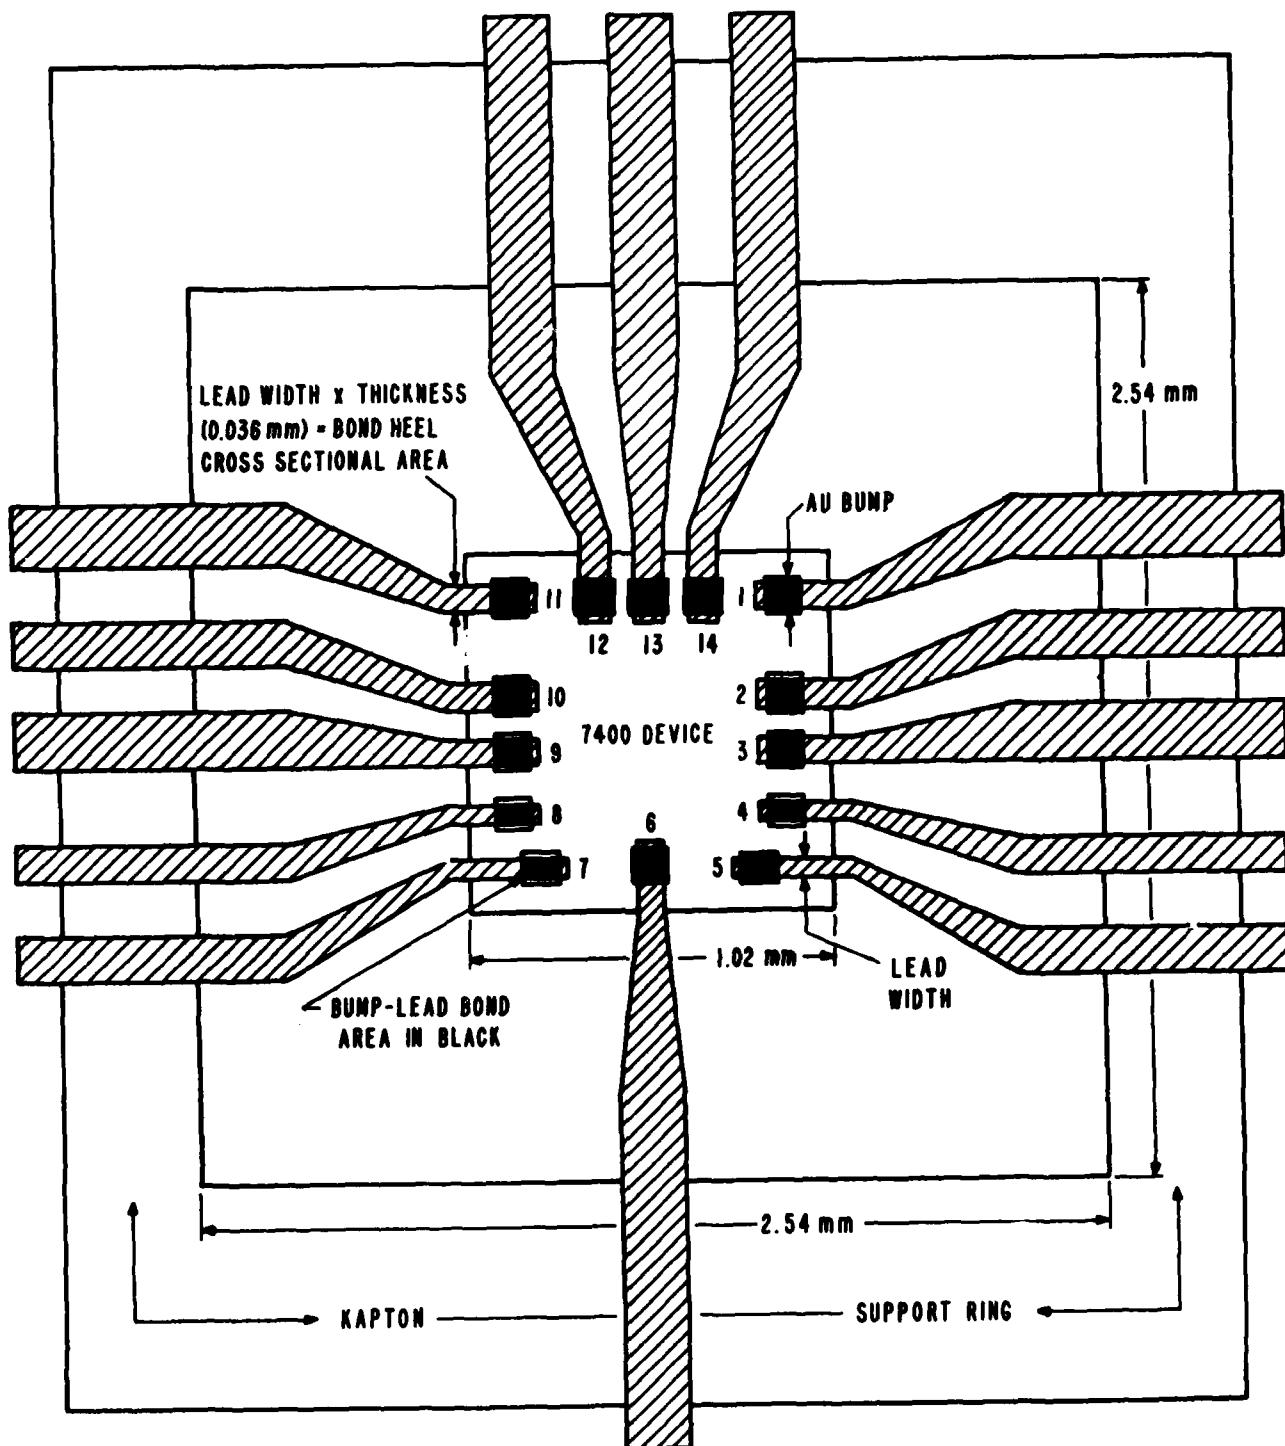
Figure 7. Configuration of an ILB 7400 device

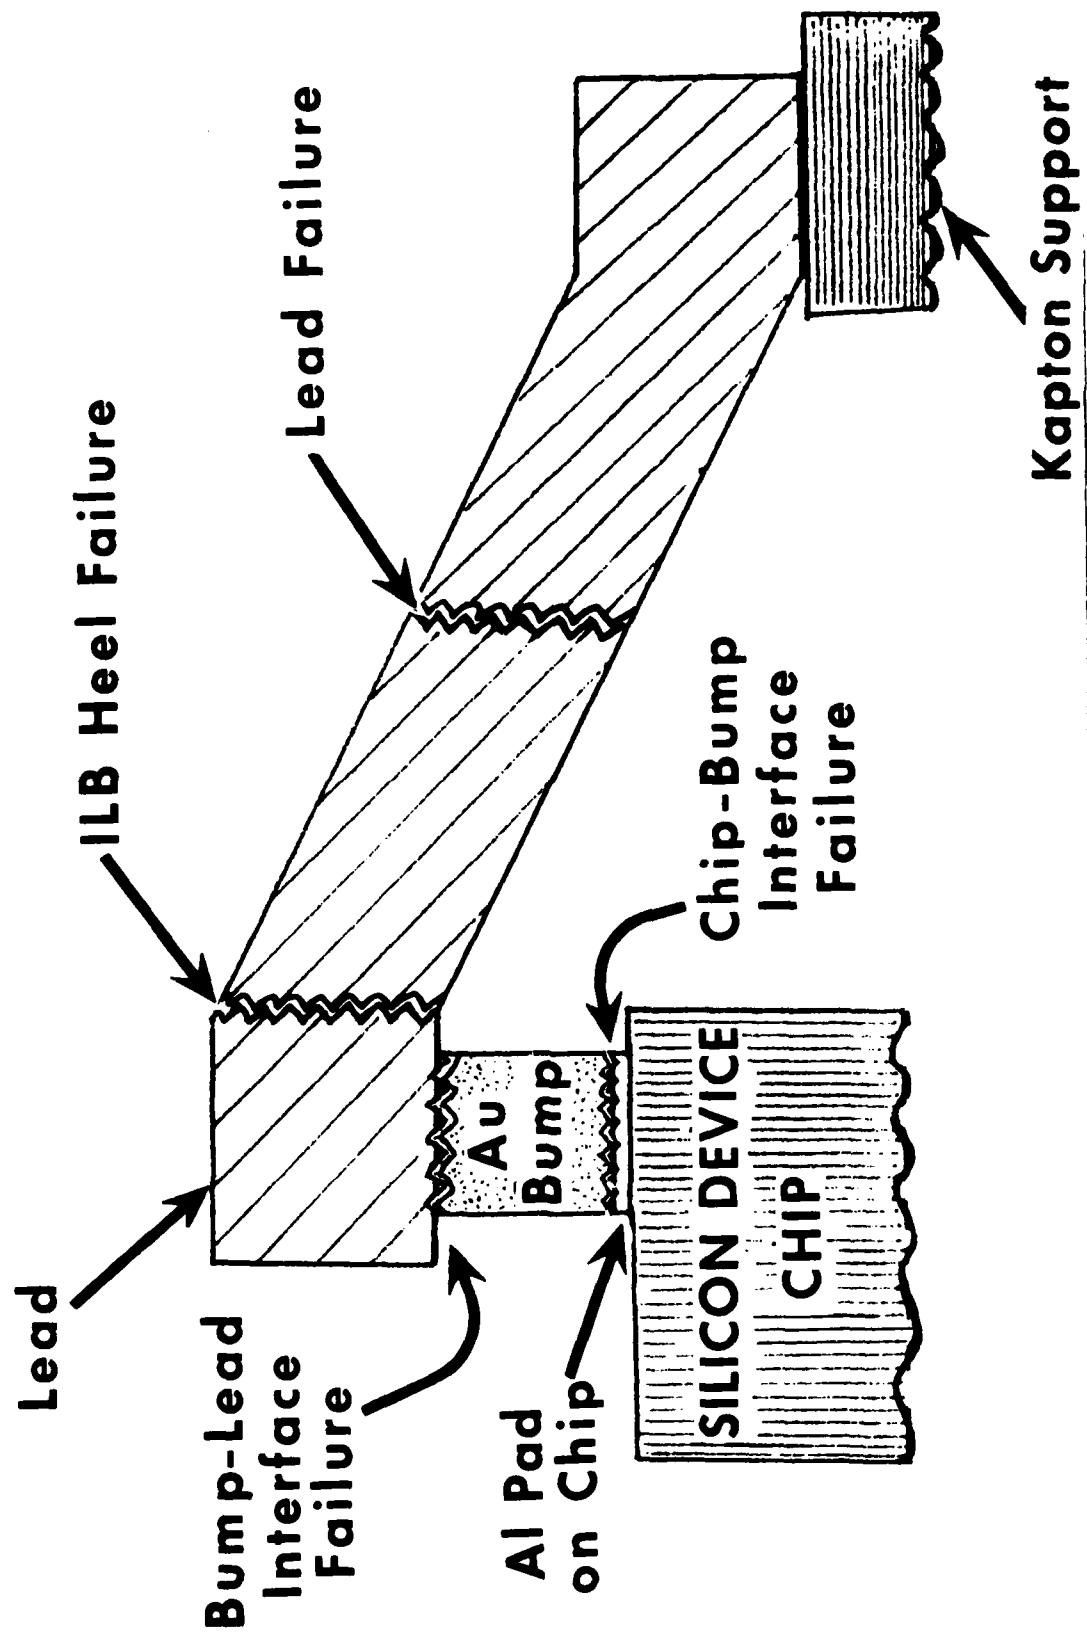
Destructive type pull tests were used in evaluating approximately 2800 ILB which were comprised of an almost equal number of Au Bump-Sn, Au Bump-10000 angstrom Au, and Au Bump - 32000 angstrom Au samples. A suitable ILB sample was one that exhibited only lead tensile failure. Under that condition, the bond strengths at chip-bump and bump-lead interfaces would necessarily be greater than the lead tensile strength. Therefore, the greater the percent lead failure - the more reliable the ILB metallurgical system. Pull tests were performed first to determine the combination of bonding parameters which would yield the greatest ILB pull strengths for each of the three evaluated systems. The bonding parameters varied were: thermode temperature (°C), thermode pressure (psi), and thermode dwell time (s). The optimum combination of parameters also had to provide the proper amount of bonding heat to release the ILB chip from its wax-mounting or adhesive-mounting. Excessive heat could undesirably change the orientation of chips surrounding the ILB chip and therefore affect subsequent inner lead bonding. Pull testing of ILB samples revealed several failure modes: bond failure at the Al pad-bump metallization interface (hereafter referred to as chip-bump failure), failure of the ILB (bump-lead failure), and tensile failure of the lead (lead failure). Failure at the heel of the bond also occurred, but only with the Au-Au samples. The pull test failures modes are graphically described in Figure 9.

Figure 9. Pull test failure modes related to ILB

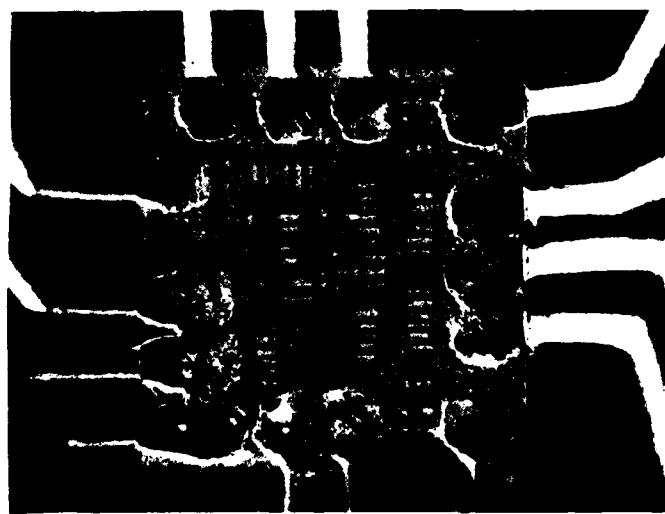
Inner lead bonding trials for Au bump - 32000 angstrom thick Au plated Cu lead samples were performed with bonding conditions previously found optimum for the 10000 angstrom thick Au system. The trials resulted in ILB chips with intolerable bump deformation and bump contact. This is

illustrated in Figure 10. Bonding temperature, dwell time, and pressures were then reduced to try to resolve the problem of excessive deformation of bumps. As shown in Figure 11, essentially the same effect occurred using reduced condition levels including a 12 psi bonding pressure (instead of 32 psi). The problem of excessive bump deformation was attributed to an extra thick support plate used in mounting the bumped 5410 wafer. Significant reduction of deformation was obtained using a combination of 5 psi bonding pressure and 2.5 psi approach pressure. The resultant bumps are shown in Figure 12. Conditions of 450°C thermode - 5 psi bonding pressure - 2.5 psi approach pressure, and dwell times of 0.2, 0.3, and 0.4s were evaluated to determine optimum bonding for the 32000 angstrom samples. Bonded samples were later subjected to 275°C for 4 hours prior to pull tests. Table 8 below summarizes the pull test results. The largest gram force values were obtained with samples bonded with a 0.2s thermode dwell.

Figure 10. 475°C - 32 psi - 5 psi -
0.8s Effect on Bump
Deformation (55x)

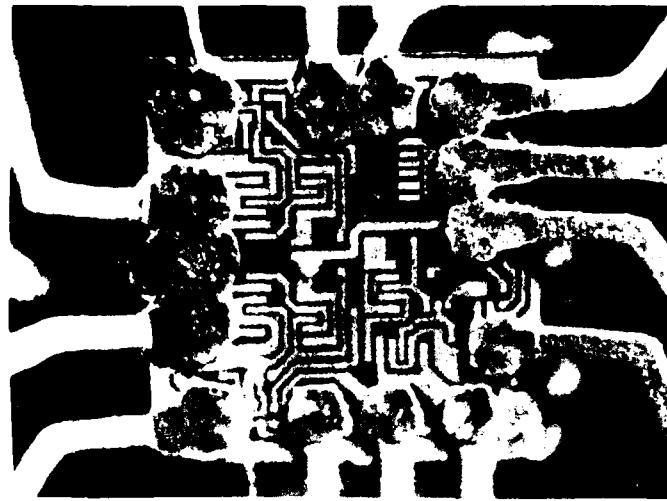
Figure 11. 450°C - 12 psi - 5 psi - 0.5s
Effect on Bump Deformation (55x)

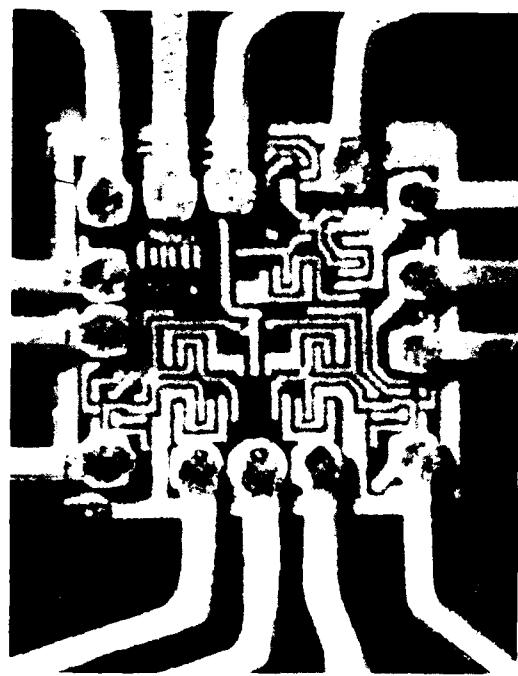
Optimum bonding conditions of 450°C thermode - 5 psi bond pressure - 2.5 psi approach pressure - 0.2s dwell time were used to ILB additional Au bump - 32000 angstrom thick Au plated Cu lead samples. After bonding, the samples were subjected to elevated temperatures in a range from 150°C to 300°C for various time periods. Exposed samples (and controls) were destructively pull tested using the procedure described previously in this report. Gram and kg/mm² values (average) for chip-bump and lead failures and standard deviations (based on kg/mm² values) are presented in Table 9. The overall average pull strength, in grams, for each exposure group is included. The most significant results of this evaluation follow:

Figure 12. 450°C - 5 psi - 2.5 psi - 0.2s
Effect on Bump Deformation (55x)
